East Coast Leisure

Re: Franciscus Homes
10 Rosiland Way
Hampton, VA 23669
757-214-3668
757-345-3817
sdyoung@unitedpropertyassociates.com

Estimate

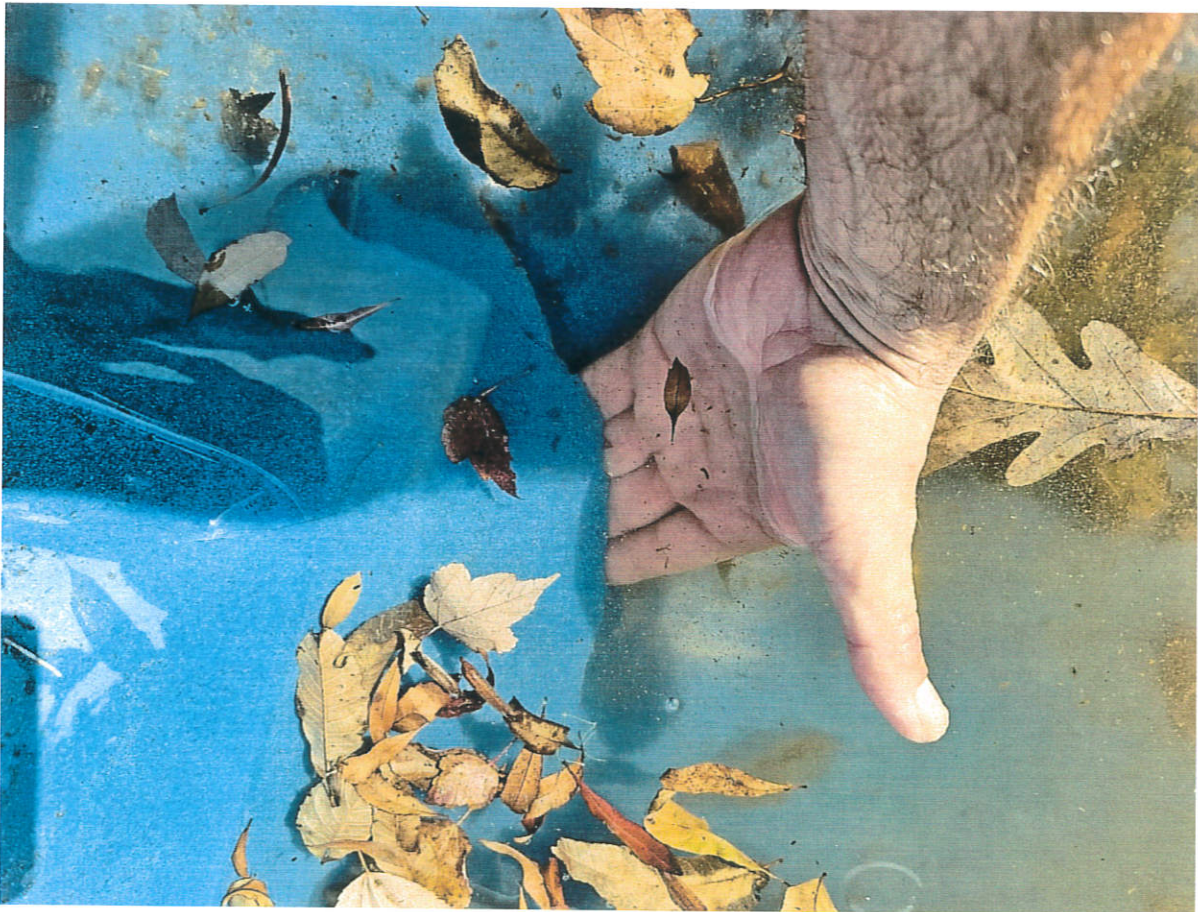
Photo: [rma--16474.jpg](#)

From the pictures provided to ECL, in our experience the plumbing near the fence was compromised due to the accident. The water leaking around the pool and out of the pool can create hydrostatic pressure. This allows voids behind the shell and uplifts the pool. This will cause cracks and allow the pool to pop out of the ground.

Reason for Return:
Details: Tear in fiberglass pool - Please contact Sharon Young at sdyoung@unitedpropertyassociates.com

Description	Amount
Fiberglass Repair - Cut out cracked area around step in deep end of pool. Build backing block and glue in sister catches. Glue cut out pieces back in. Once cured grind out around repaired area 6-8 inches beyond repair. Glass with multiple layers of 1708 fiberglass. Once cured grind and feather edges. Apply faring filler. Sand and fare. Fill lows and imperfections sand and fare. Prime with matching gel coat. Sand and fare. Sand around repaired area with 600 grit. Clean/ tape/ plastic. Wipe down and spray multiple layers of matching gel coat. Once cured wet sand in progression from 180- 1500. Compound. Remove tape and plastic. Fill dings on steps. Fare. Prime. Sand fare. Spray with matching gel coat. Wet sand and compound. - price includes all labor/ materials/ travel cost to do repair to completion ** estimate for one corner/ corner that is cracked. If deemed other side needs to be repaired than double estimate.	\$7,950.00

Water Control and Prep - Fill water barrels and bladder to weigh down pool bottom. Setup well point under pool. Brace walls. Clean area after repair work has been completed. East Coast Leisure is not responsible for any additional damage to the pool during repair work.	\$2,500.00
TOTAL BALANCE	
	\$10,450.00
